# HOW TO READ YOUR ROOF

**UNDERSTANDING THE NATURAL AGING  
PROCESS OF ASPHALT SHINGLES**

**TAMKO**<sup>®</sup>  
BUILDING PRODUCTS

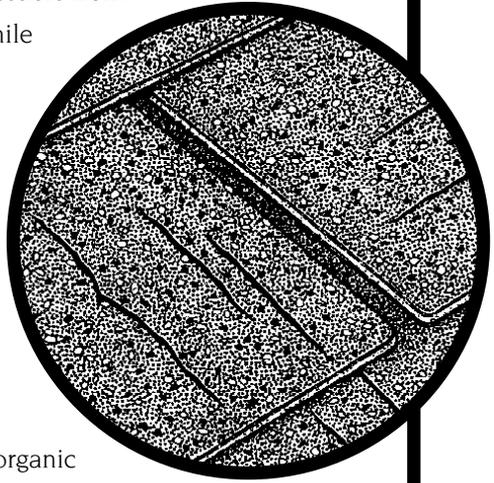
## **SURFACE CRACKING**

While minor cracks may not be noticeable from the ground, you might spot them while hanging your Christmas lights. Intense heat from the sun often allows protective asphalt oils to deplete, causing minor cracks. Keep in mind that these normal weathering characteristics are not cause for alarm as long as your shingles are still providing the intended protection. Cracks that penetrate through the fiberglass or organic mat should be investigated.

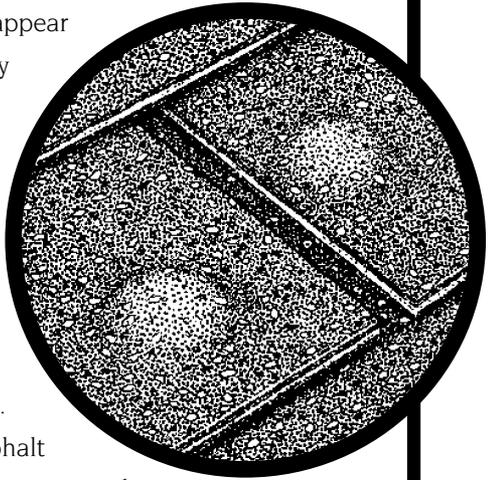
## **BLISTERS**

Occasionally, naturally occurring small circular raised areas known as blisters may appear on your roof. These pockets may vary in size and be open (exposing the asphalt) or closed. Blisters are often a direct result of underventilated attics or excessive use of plastic cement. Closed blisters are not reason for concern as long as your roof is providing the intended protection. However, open blisters do mean asphalt is exposed and immediate attention is required.

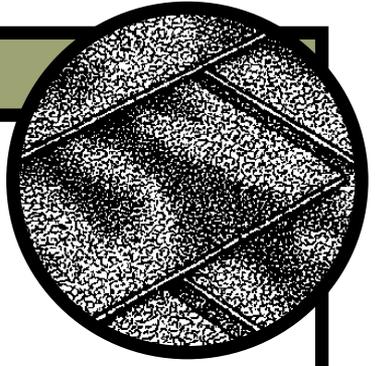
## ALGAE STAINS

In moist, humid areas, dark brown or black patches may appear on roofs. These streaks result in a dirty rooftop, often more visible on lighter-colored shingles. This naturally occurring stain is caused by fungus growth and will not affect the protective qualities of your shingles. Algae discoloration should not be confused with moss or tree droppings, which typically produce only localized discoloration.

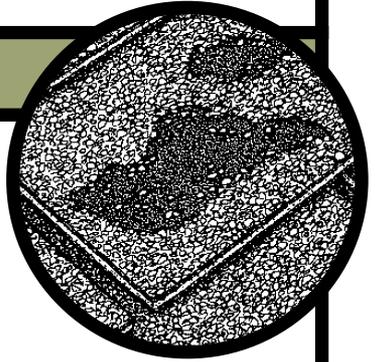
## GRANULE LOSS

Since extra granules are used in the manufacturing process, some granule loss is to be expected during the early years of your roof. Other factors such as foot traffic, hail, snow or brushing tree limbs may cause loose granules. However, exposed asphalt due to granule loss is a reason for concern and warrants immediate attention.

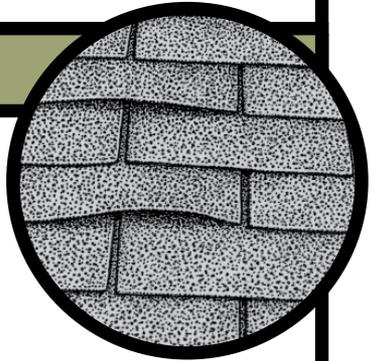
## BUCKLING

While not technically a sign of aging, a distortion of shingles known as buckling can occur months after original application. Lack of adequate attic ventilation can increase the moisture content of the decking material. This may cause expansion and movement of the wood deck to buckle shingles.
